INDOOR AIR QUALITY ASSESSMENT

**Glover School
255 Canton Avenue
Milton, MA 02186**

Prepared by:
Massachusetts Department of Public Health
Center for Environmental Health
Emergency Response/Indoor Air Quality Program
June 2005

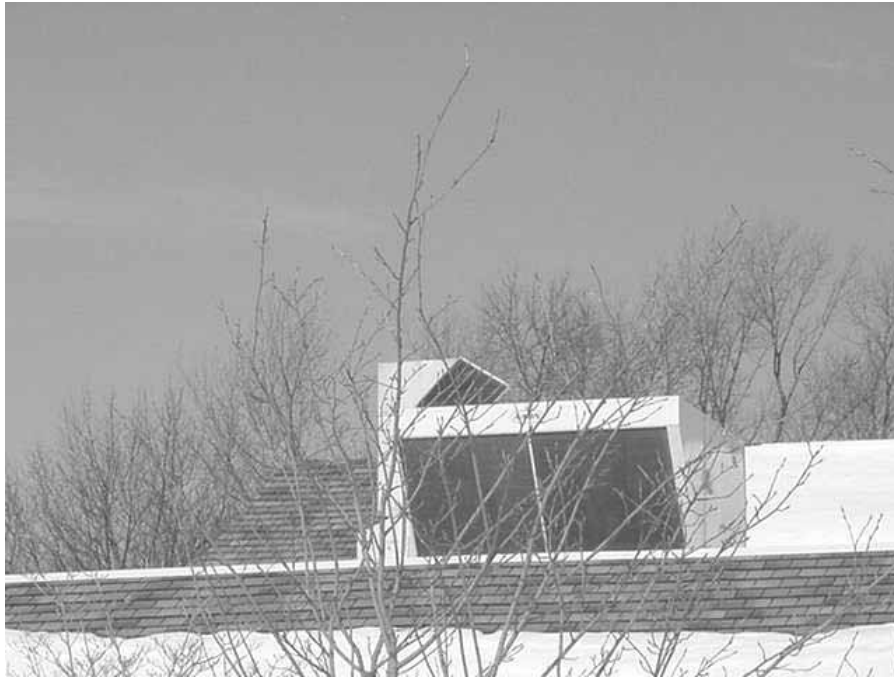
Picture 1

Rooftop air-handling unit

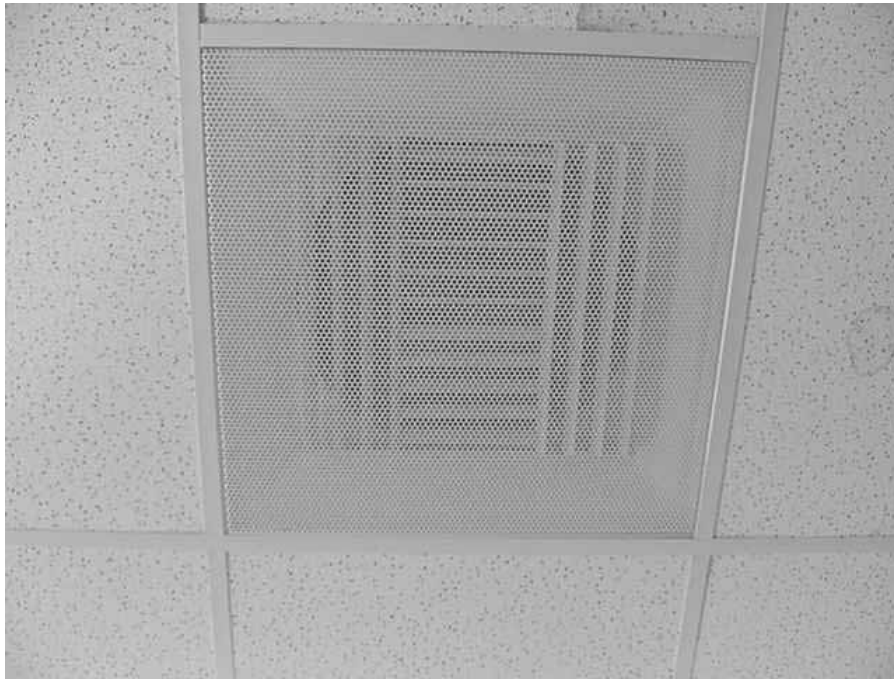
Picture 2

Ceiling ducted supply

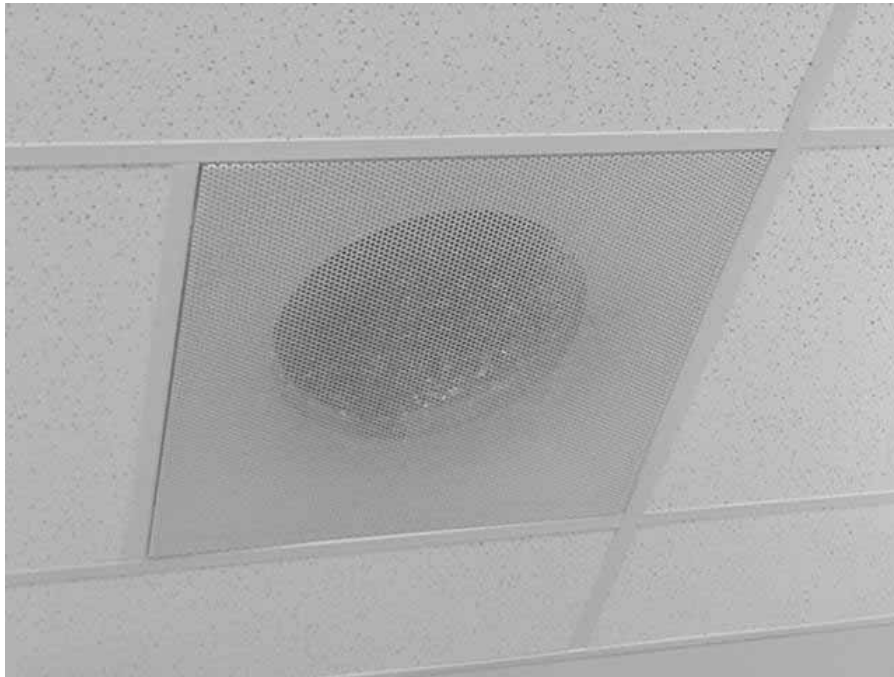
Picture 3

Ceiling ducted exhaust

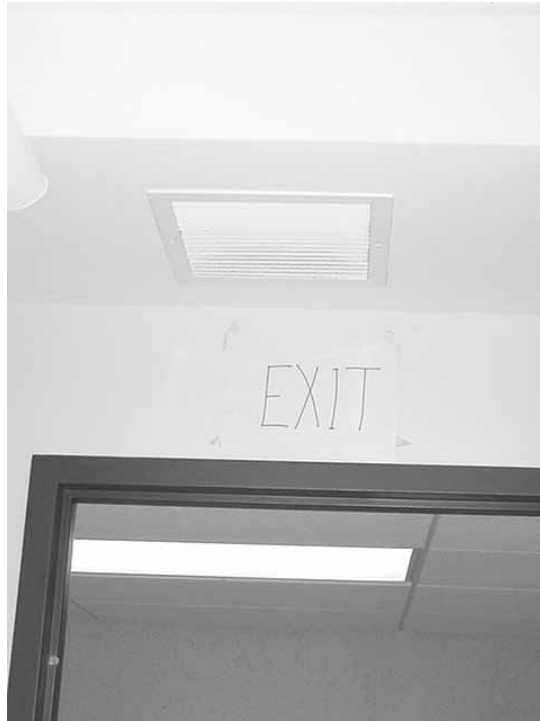
Picture 4

Exhaust near classroom door to hallway

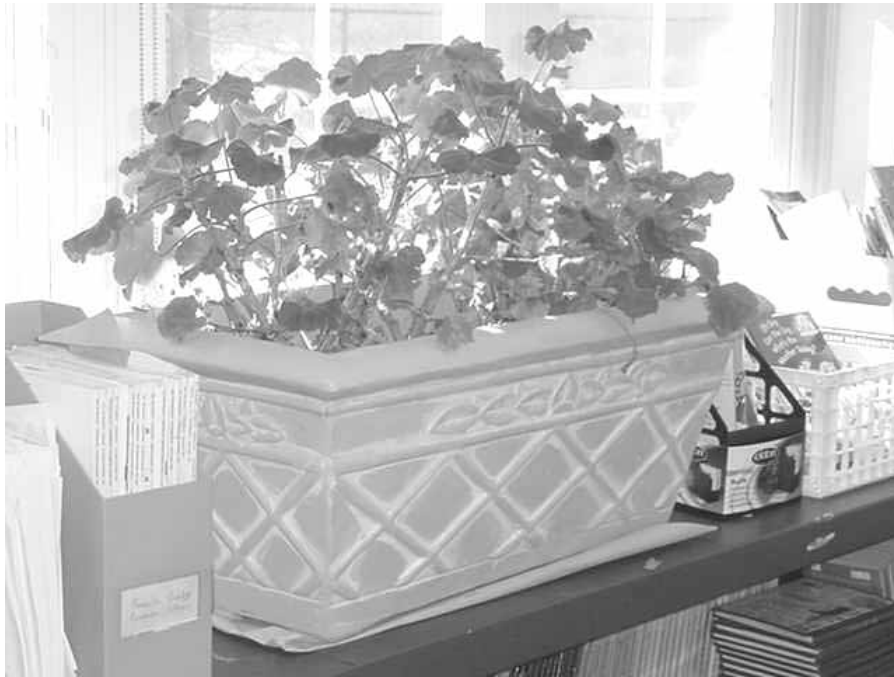
Picture 5

Plants were observed in several classrooms and, in some cases, on paper materials (Picture 5). Plants, soil and drip pans can serve as sources of mold growth. Plants should be properly maintained, over-watering of plants should be avoided and drip pans should be inspected periodically for mold growth. Plants should also be located away from ventilation sources to prevent aerosolization of dirt, pollen or mold.

Plant on paper material

9. Ensure all plants are equipped with drip pans. Examine drip pans periodically for mold growth and disinfect with an appropriate antimicrobial where necessary.

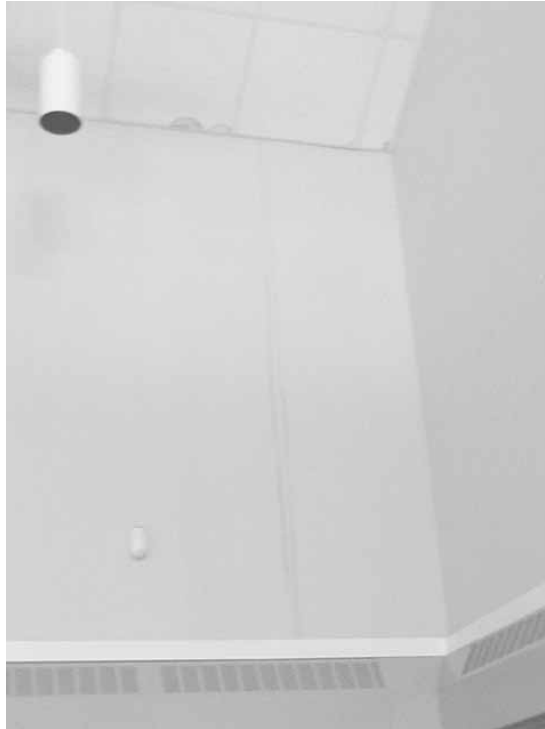
Picture 6

A number of areas had water-stained ceiling tiles, which can indicate leaks from the roof or plumbing system (Picture 6). Stains were also noted on gypsum wallboard (Picture 6). Water-damaged porous building materials can provide a source for mold and should be repaired/replaced after a water leak is discovered and repaired.

Water damaged ceiling tile and gypsum wallboard

The US Environmental Protection Agency (US EPA) and the American Conference of Governmental Industrial Hygienists (ACGIH) recommend that porous materials be dried with fans and heating within 24 to 48 hours of becoming wet (US EPA, 2001; ACGIH, 1989). If porous materials are not dried within this time frame, mold growth may occur.

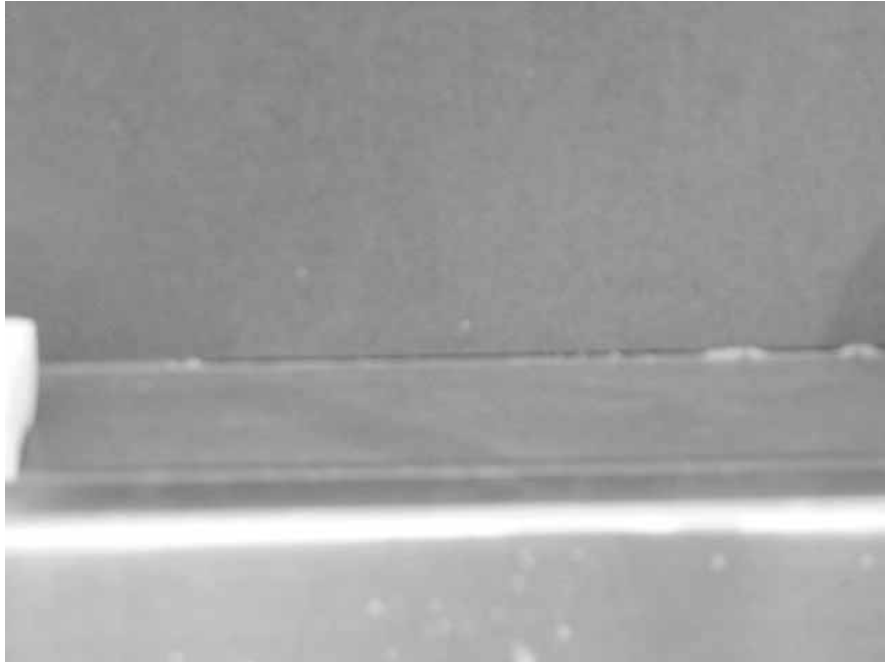
Picture 7

Lastly, spaces between the sink countertop and backsplash were seen in several areas (Picture 7). Improper drainage or sink overflow can lead to water penetration into the countertop, cabinet interior and areas behind cabinets. If these materials become wet repeatedly they can provide a medium for mold growth.

breach between sink countertop and backsplash

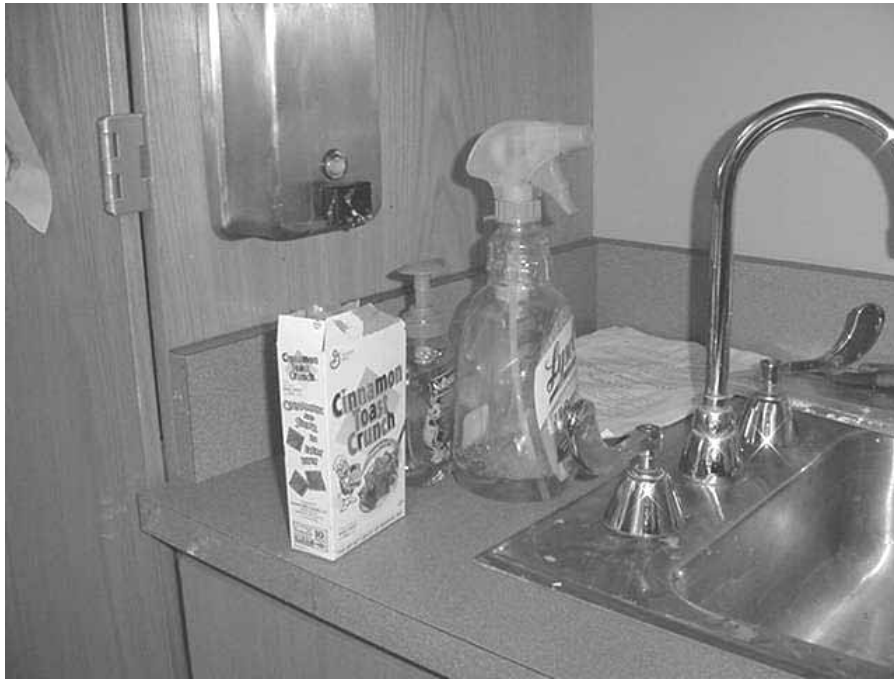
Picture 8

Cleaning products were also found on countertops and in unlocked cabinets beneath sinks in some classrooms (Picture 8). Like dry erase materials, cleaning products contain VOCs and other chemicals that can be irritating to the eyes, nose and throat of sensitive individuals. Several areas contain photocopiers and lamination machines. VOCs and ozone can be produced by photocopiers, particularly if the equipment is older and in frequent use. Ozone is a respiratory irritant (Schmidt Etkin, 1992). Lamination machines can produce irritating odors during use. These areas are equipped with local exhaust ventilation; occupants should ensure that vents are operating to help reduce excess heat and odors.

Improperly stored food and re-use of food containers were noted (Picture 8). Proper food storage is an integral component in maintaining indoor air quality. Food should be properly stored and clearly labeled. Reuse of food containers is not recommended since food residue adhering to the surface may serve to attract pests. School officials stated that an IPM plan was in place and that baited traps were used in several areas. To prevent pest infestation, pathways for ingress and attractants (i.e., food) should be reduced/eliminated.

Cleaners on sink countertop

10. Store cleaning products properly and out of reach of students.
11. Relocate or consider reducing the amount of materials stored in classrooms to allow for more thorough cleaning. Clean items regularly with a wet cloth or sponge to prevent excessive dust build-up.

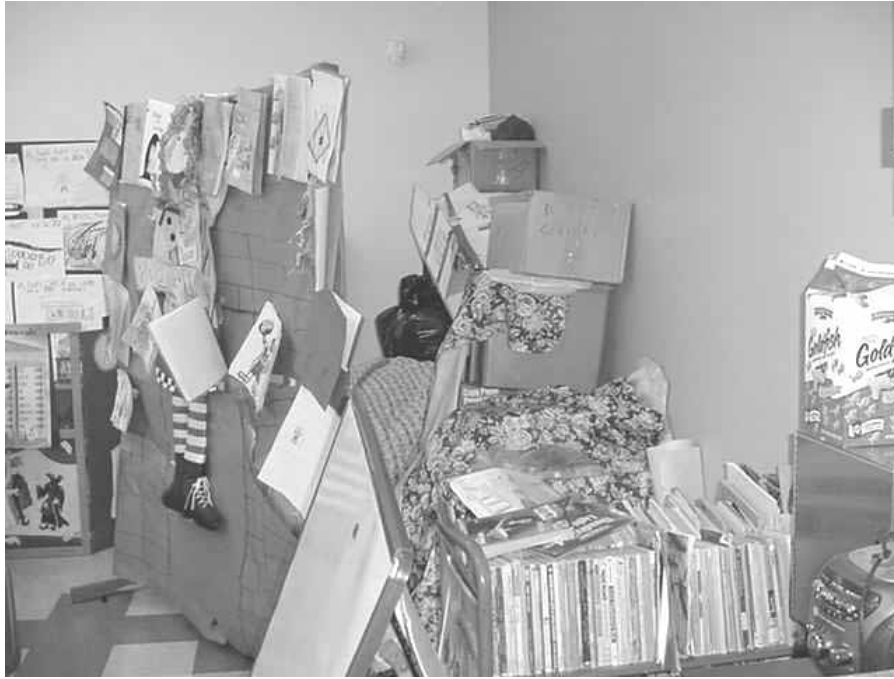
Picture 9

Several other conditions that can affect indoor air quality were noted during the assessment. In some classrooms, items were observed on windowsills, tabletops, counters, bookcases and desks or piled into the corner of rooms (Picture 9). The large number of items stored in classrooms provides a source for dusts to accumulate. These items (e.g., papers, folders, boxes) make it difficult for custodial staff to clean. Items should be relocated and/or be cleaned periodically to avoid excessive dust build up. To prevent dust accumulation, flat surfaces should be wet-wiped and vacuumed periodically with a vacuum equipped with a high efficiency particle arrestance (HEPA) filter.

Items stored in corner of classroom

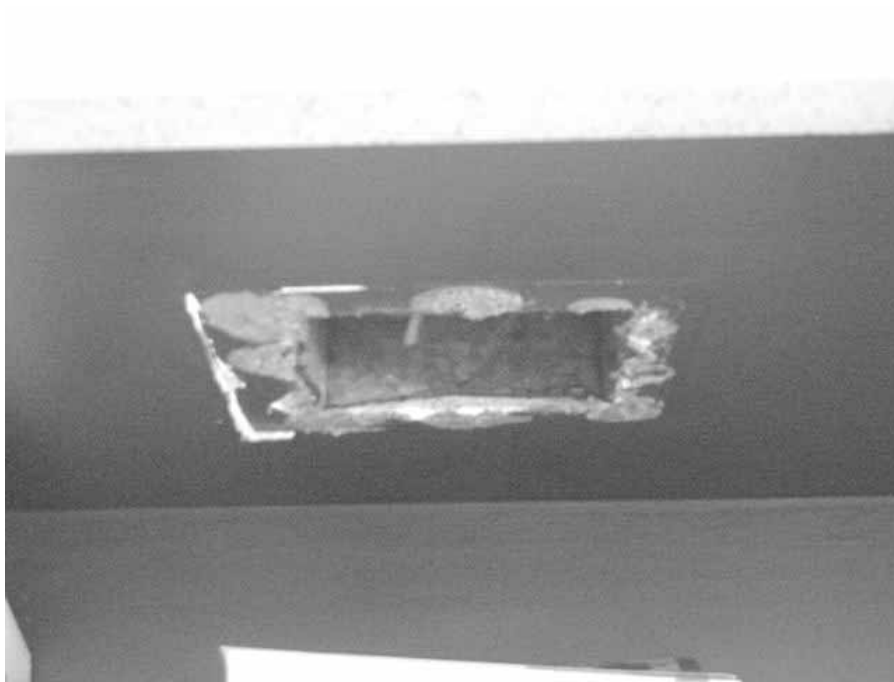
Picture 10

A number of exhaust/return vents in classrooms and restrooms had accumulated dust. If exhaust vents are not functioning, backdrafting can occur, which can re-aerosolize dust particles. Similarly, covers to exhausts vents that had been deactivated were loose or not intact in many rooms (Picture 10). This can result in dust accumulation in their ducts that can be re-aerosolized due to backdrafting. Fan blades to personal fans were also noted with accumulated dust (Picture 11). When these fans are activated, dust can become aerosolized. As discussed, dust can accumulate on flat surfaces (e.g., desktops, shelving and carpets) in occupied areas and subsequently be re-aerosolized causing further irritation. Dust can be irritating to eyes, nose and respiratory tract.

Missing cover to deactivated exhaust

12. Replace coverings to deactivated exhaust vents to prevent aerosolization of dust through backdrafts.
13. Clean accumulated dust from exhaust vents and blades of personal fans.

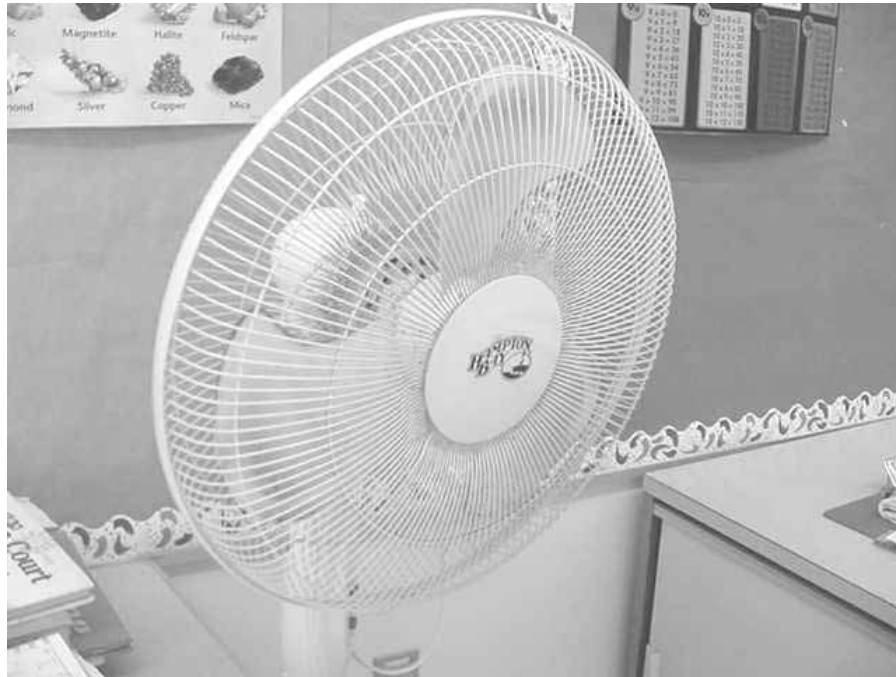
Picture 11

Dust occluding fan blades

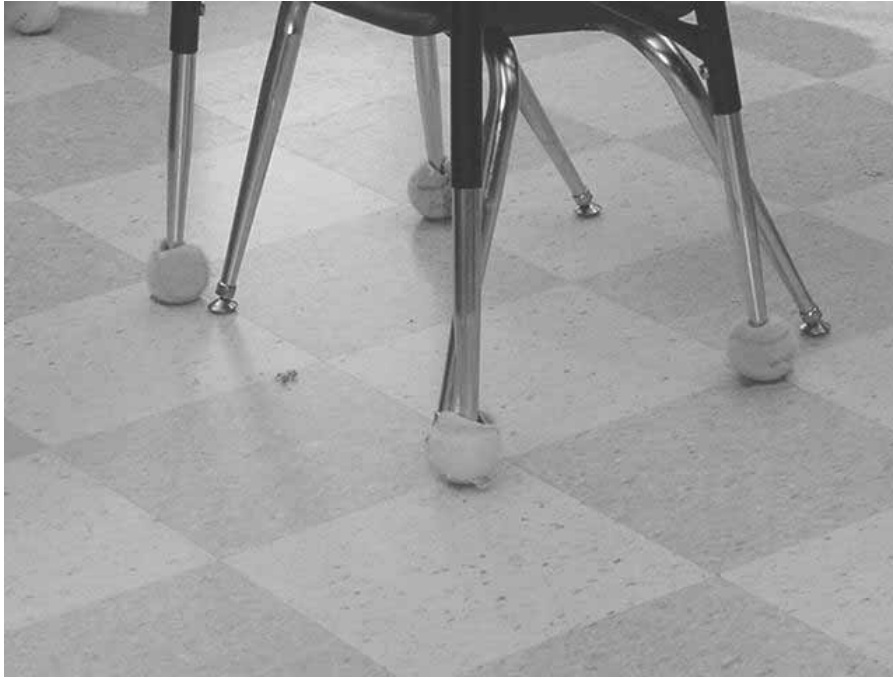
Picture 12

In an effort to reduce noise from sliding chairs, tennis balls had been sliced open and placed on chair legs (Picture 12). Tennis balls are made of a number of materials that are a

source of respiratory irritants. Constant wearing of tennis balls can produce fibers and cause TVOCs to off-gas. Tennis balls are made with a natural rubber latex bladder, which becomes abraded when used as a chair leg pad. Use of tennis balls in this manner may introduce latex dust into the school environment. Some individuals are highly allergic to latex (e.g., spina bifida patients) (SBAA, 2001). It is recommended that the use of materials containing latex be limited in buildings to reduce the likelihood of symptoms in sensitive individuals (NIOSH, 1997). A question and answer sheet concerning latex allergy is attached as [Appendix B](#) (NIOSH, 1998). Consider replacing tennis balls with alternative glides (Picture 13).

Tennis balls on chair legs

14. Discontinue the use of tennis balls on chairs to prevent latex dust generation. Alternative “glides” can commonly be purchased from office supply stores.

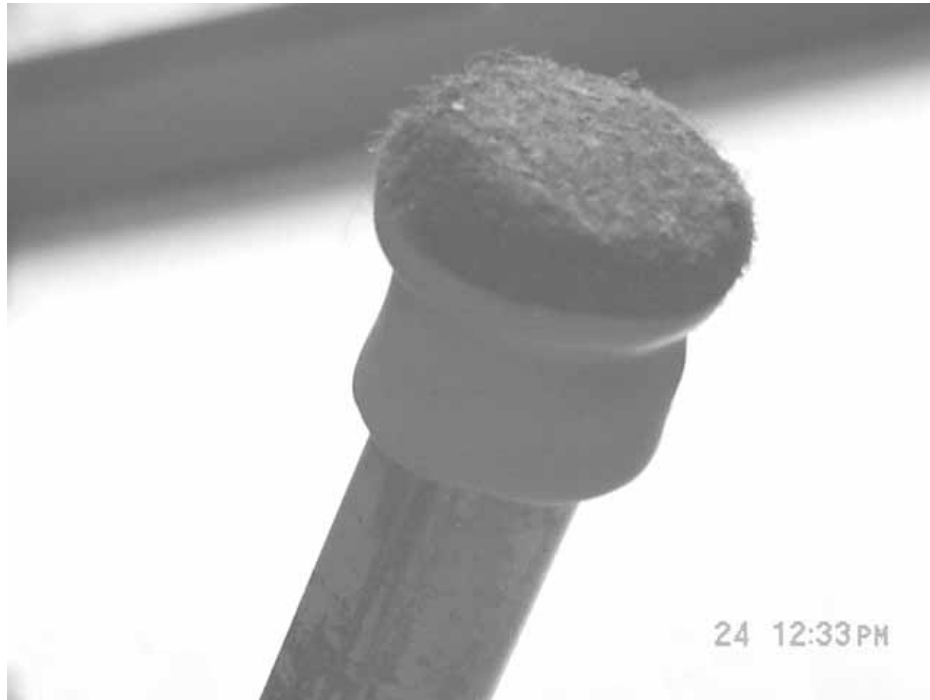
Picture 13

“Glides” for Chair Legs That can be Used as an Alternative to Tennis Balls

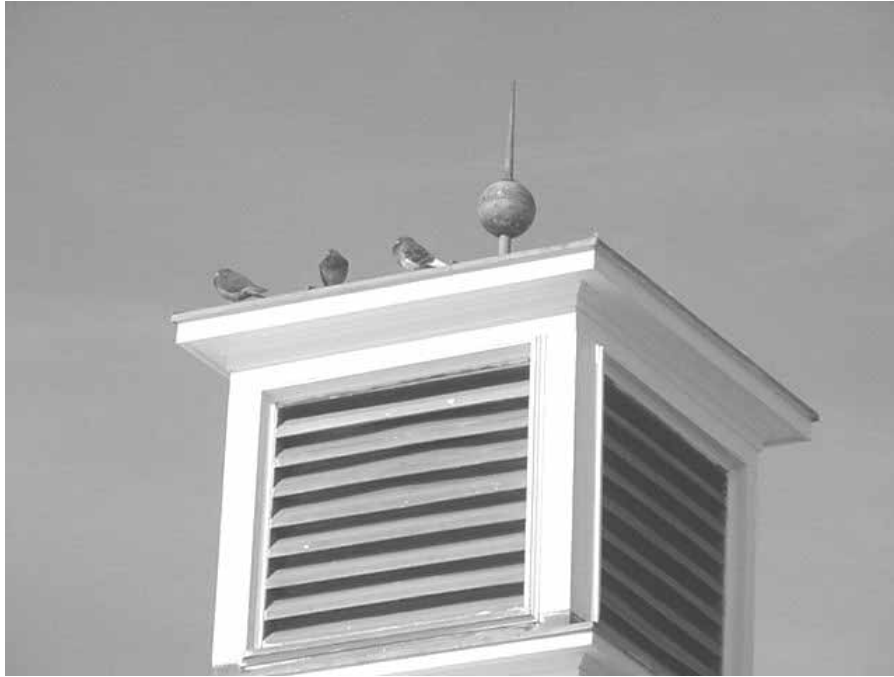
Picture 14

Lastly, birds were observed near an exhaust tower (Picture 14). To prevent bird roosting within the tower, consider installing bird netting around the louvers of the tower to prevent entry. Birds can be a source of disease, and bird wastes and feathers can contain mold, which can be irritating to the respiratory system.

Birds near exhaust tower

15. Install netting/screening around exhaust tower to prevent bird roosting.
16. Ensure local exhaust ventilation is activated in areas with photocopiers and lamination machines, or relocate to a well-ventilated area.
